**PERFORMANCE PARAMETERS OF THE X-20 DYNA-SOAR
PROTOTYPE FULL PRESSURE ASSEMBLY**

TECHNICAL DOCUMENTARY REPORT No. AMRL-TDR-64-27

MAY 1964

BIOMEDICAL LABORATORY
AEROSPACE MEDICAL RESEARCH LABORATORIES
AEROSPACE MEDICAL DIVISION
AIR FORCE SYSTEMS COMMAND
WRIGHT-PATTERSON AIR FORCE BASE, OHIO

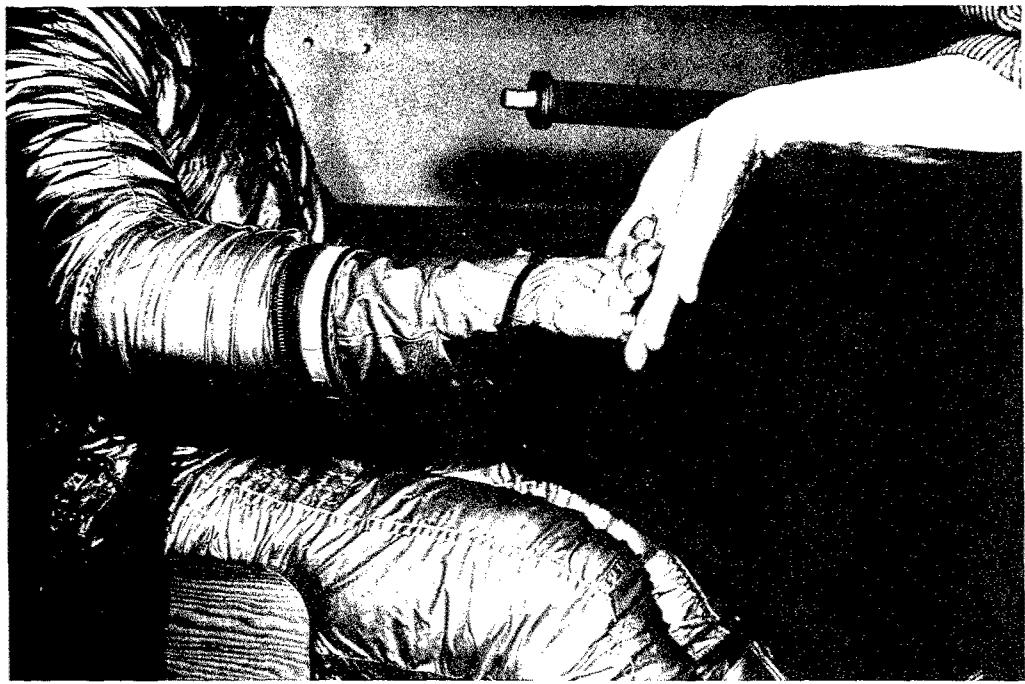
Figure 15. Glove Growth

The above measurements taken on this pressure suit are shown in table 3. Figure 15 shows the growth of the glove beyond the subject's fingers when the assembly was inflated.
